**Persimmon Homes (East Wales)**

**Ty Mawr Manor, Gilwern**

**Outline Remediation Strategy Report**

11062/GNS/12/RSR

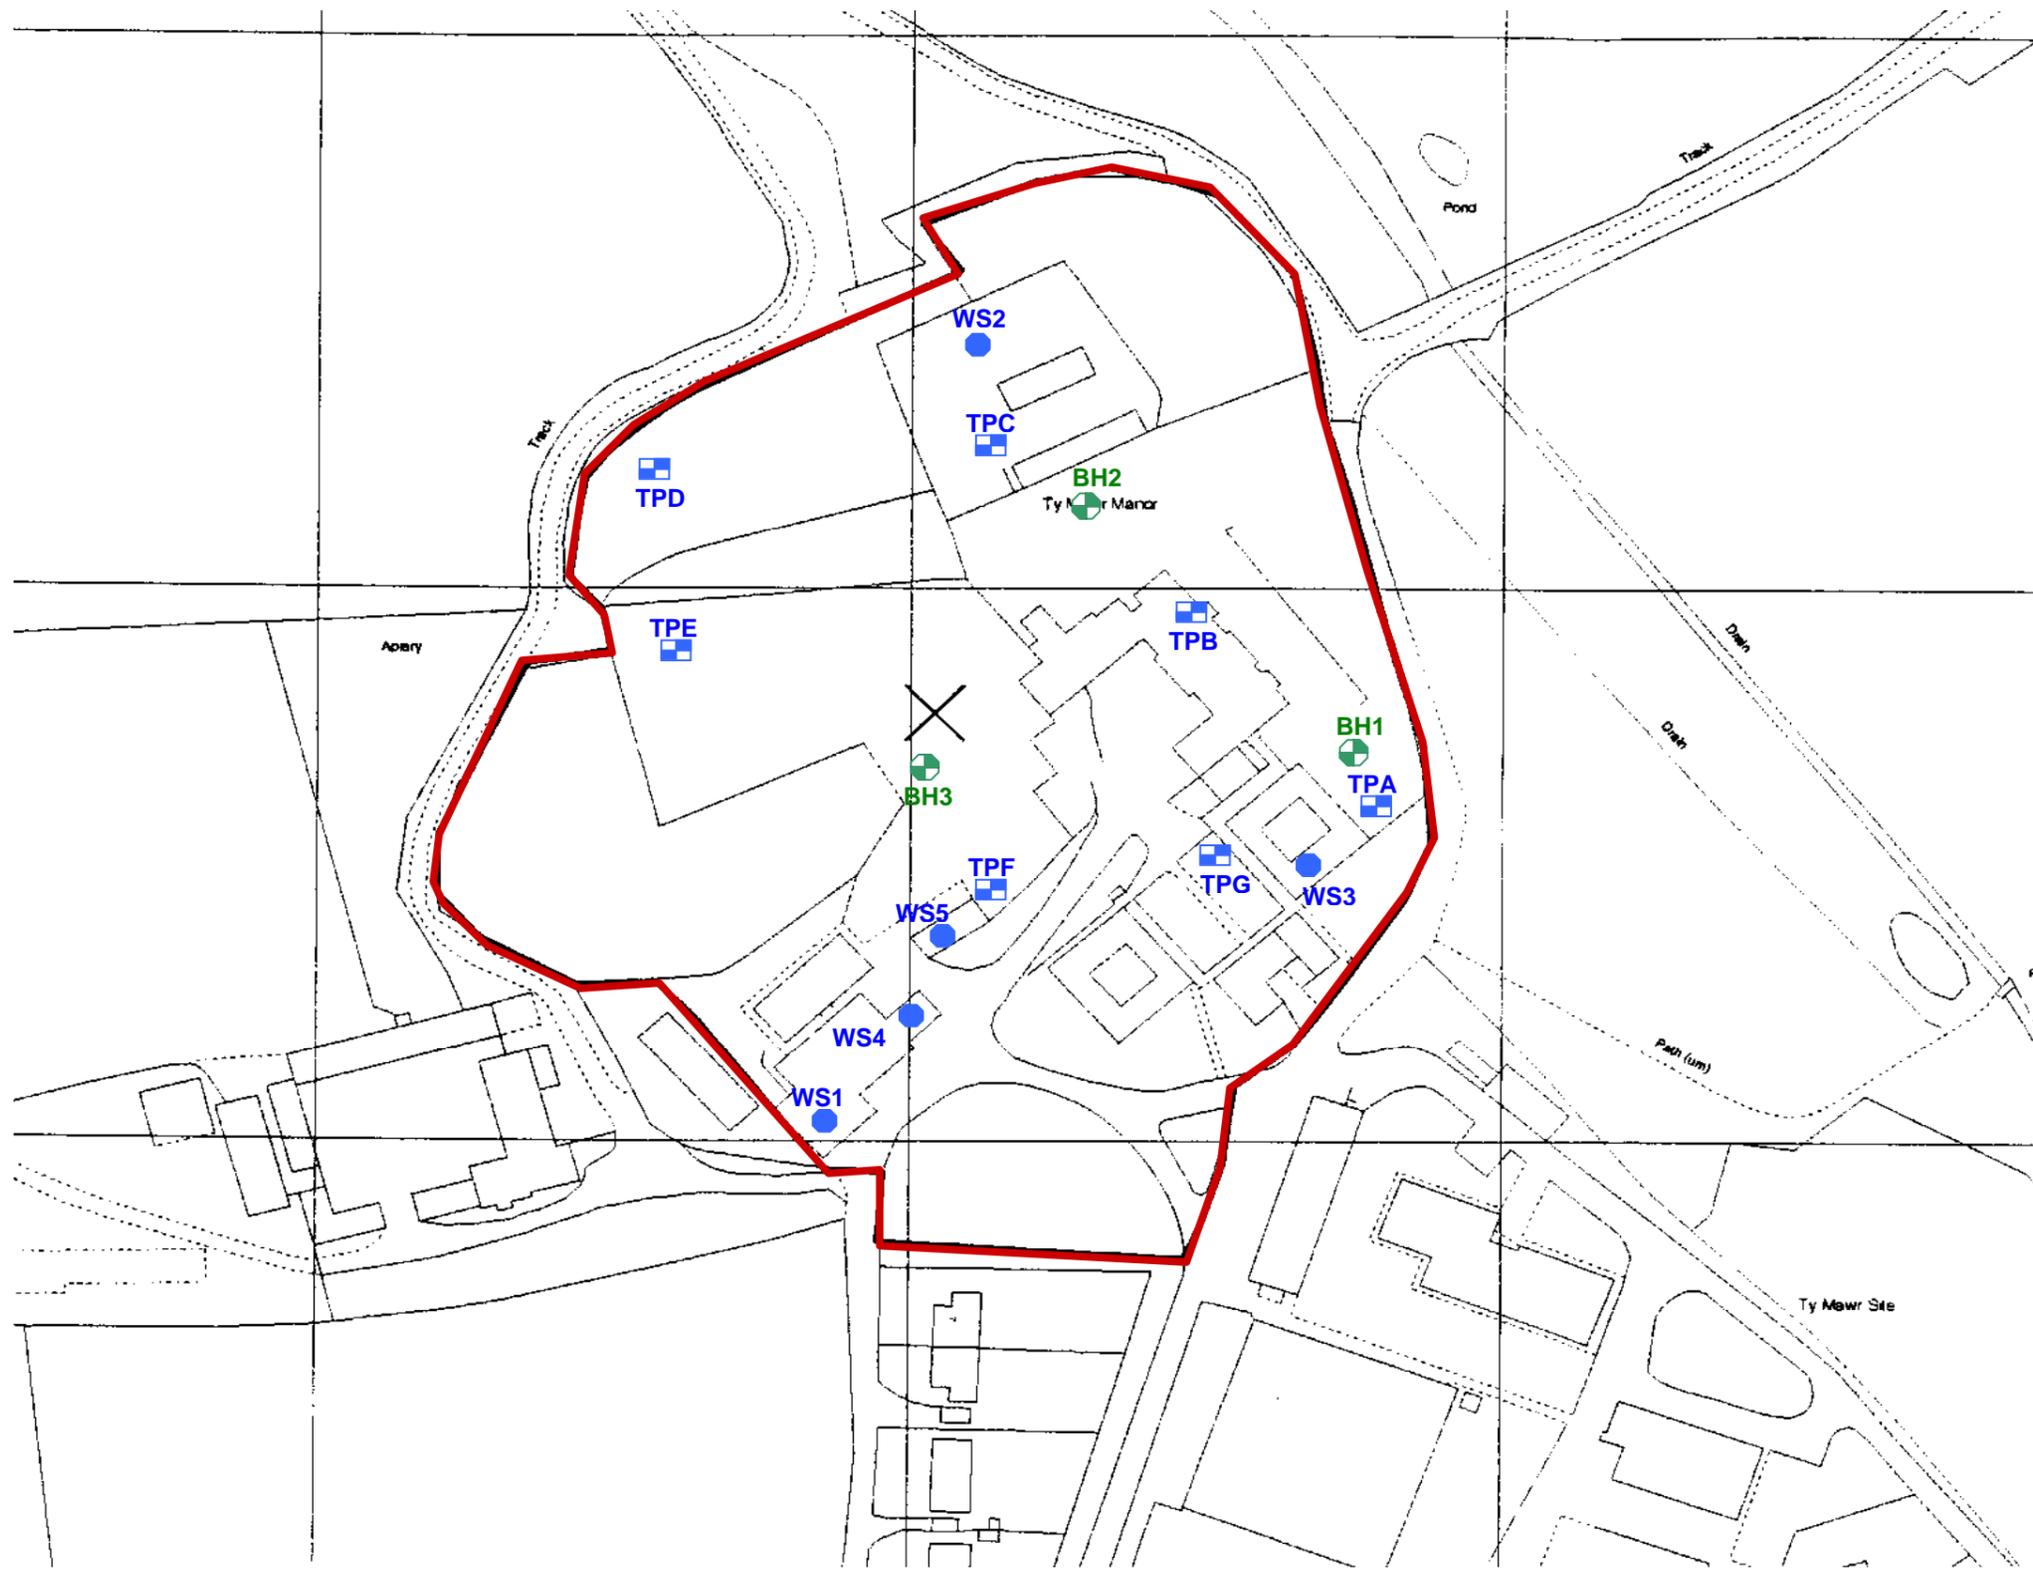
**LEGEND**

- APPROXIMATE SITE BOUNDARY
- APPROXIMATE LOCATION OF TRIAL PITS
- APPROXIMATE LOCATION OF WINDOW SAMPLE HOLES
- ⊕ APPROXIMATE LOCATION OF SHELL AND AUGER BOREHOLES
